# NATIONAL TRANSPORTATION SAFETY BOARD

## MATERIALS LABORATORY FACTUAL REPORT

Report No. 21-076

Place : Horseshoe Bend, Idaho  
Date : February 5, 2021  
Vehicle : Hughes OH-6A, N6639R  
NTSB No. : WPR21LA107  
Investigator : Eric Gutierrez, ASI-WPR

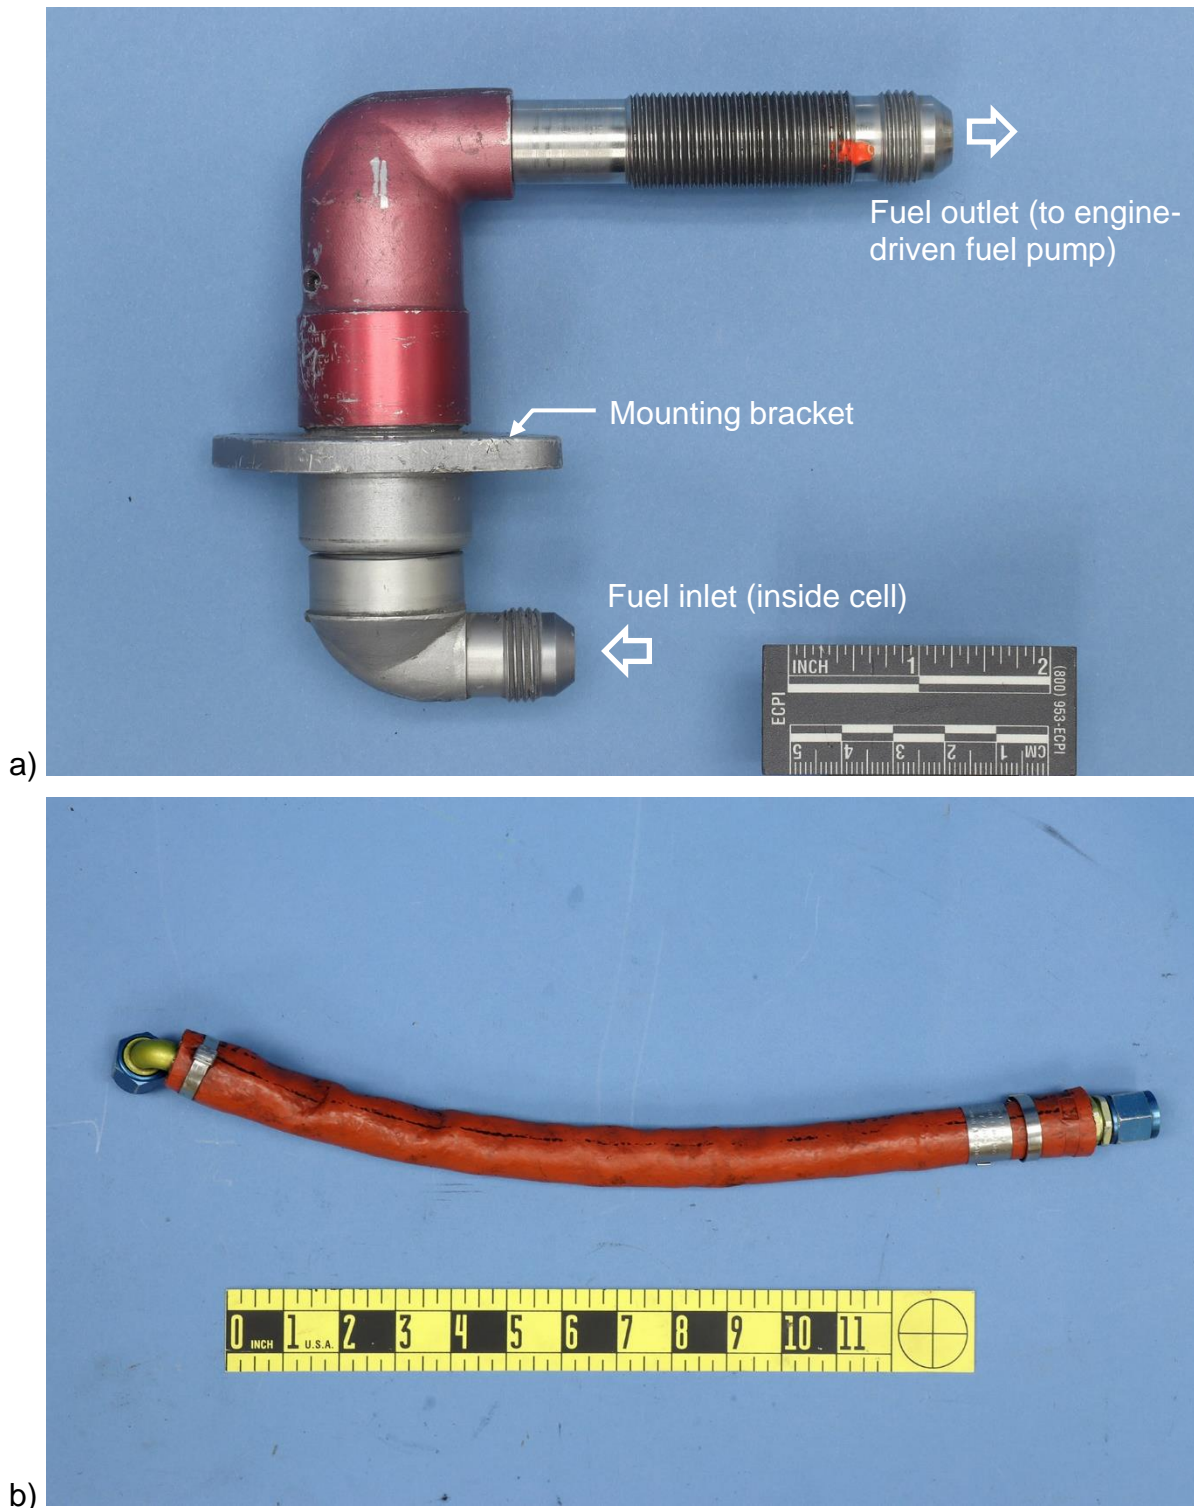
A fuel valve and flexible fuel line were sent to the NTSB Materials Laboratory for examination as shown in figures 1a and b, respectively. The two components were part of the aircraft's crashworthy fuel system. In the as-installed configuration, the valve was mounted on the exterior surface of a fuel cell by means of a mounting bracket (indicated in figure 1a) with the fuel inlet-side residing inside the cell. A separate fuel line (not examined or discussed) was connected to the valve inlet. The downstream portion of the valve was outside the fuel cell and consisted of a 90° elbow fitting followed by a length of rigid pipe. The downstream end of the pipe was threaded on the outer diameter surface for passing through and securing the pipe to a spacer/cover assembly with two nuts, one on either side of the assembly. The included fuel line was located downstream of the valve and upstream of the engine-driven fuel pump. The fuel line was visually examined but there were no notable features.

**Figure 1:** a) Image of the as-received fuel valve and b) image of the as-received flexible fuel line.

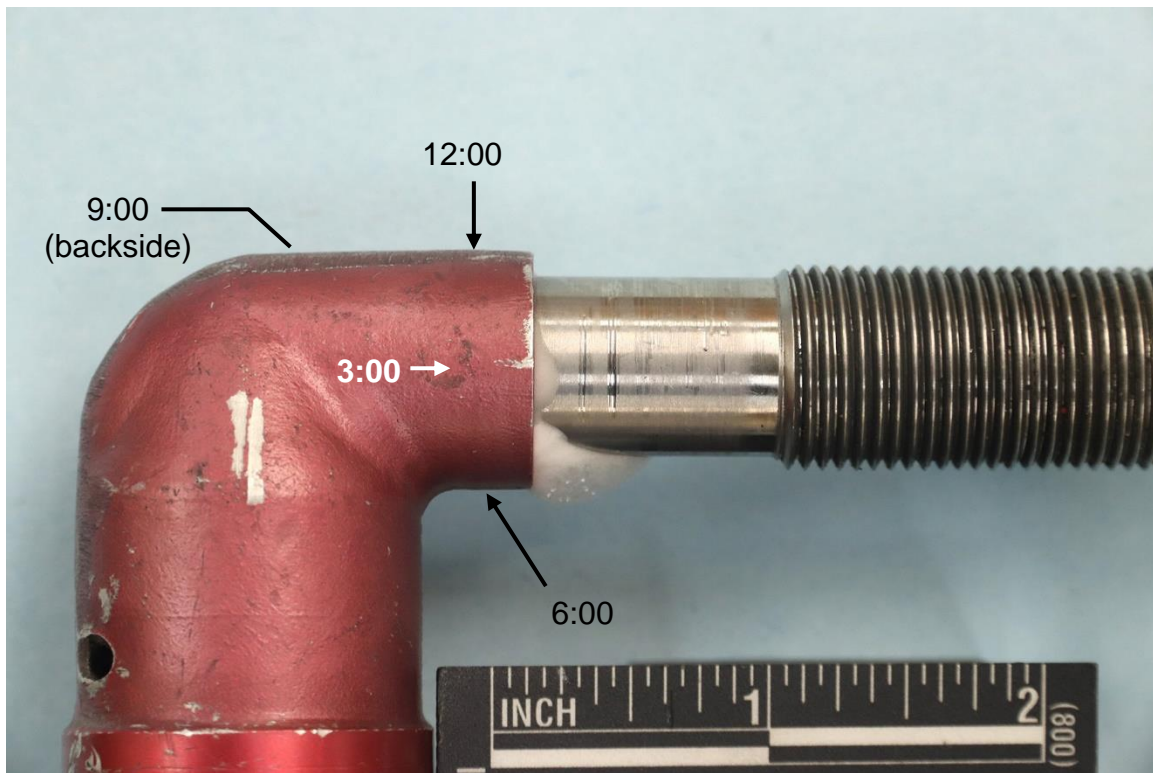
The valve reportedly was found to be leaking at the elbow fitting/pipe interface during post-accident testing in the field. The leak was reproduced in the lab by plugging one end of the valve and attaching the other end to a regulated air supply at 0.5 psi. Soapy water was applied to the elbow/pipe joint, and the soap began to foam near the 6:00 position, as defined and as shown in figure 2 (near the inner bend of the elbow fitting).

**Figure 2:** Image showing the outcome of a pressure test where soapy water was applied to the outside of a pipe where it was inserted into an elbow fitting. The soap foamed due to air leaking out of the fitting around the 6:00 position.

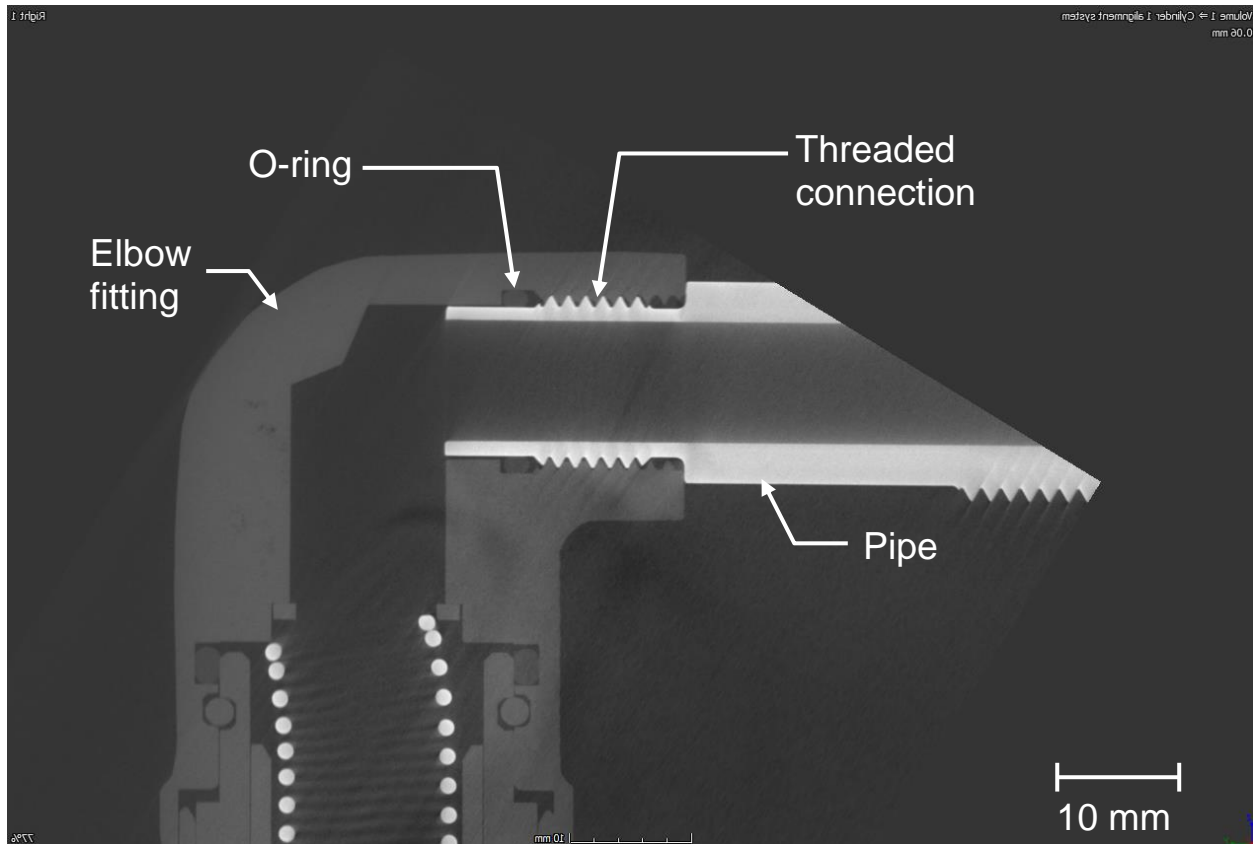
Before disassembling the valve, the elbow fitting/pipe joint was non-destructively examined using X-ray computed tomography (X-ray CT). A planar section through the CT scan is shown in figure 3. The scan revealed that the outlet of the elbow fitting contained uniform-diameter female threads into which was the pipe was threaded, with its uniform-

diameter male threads. An O-ring, compressed between smooth-wall sections of the fitting inner diameter and pipe outer diameter was used to seal the joint. The CT scan was examined for any notable features around the O-ring seal, such as a dislodged or broken ring, but none were found (It was observed however that the valve spring appeared to be partially dislodged).

**Figure 3:** Planar section from an X-ray CT scan of the valve in the vicinity of the leak. The scan revealed that the pipe was a straight barrel with a threaded connection. An O-ring that sat between the outer diameter of the pipe and the inner diameter of the elbow fitting sealed the joint.

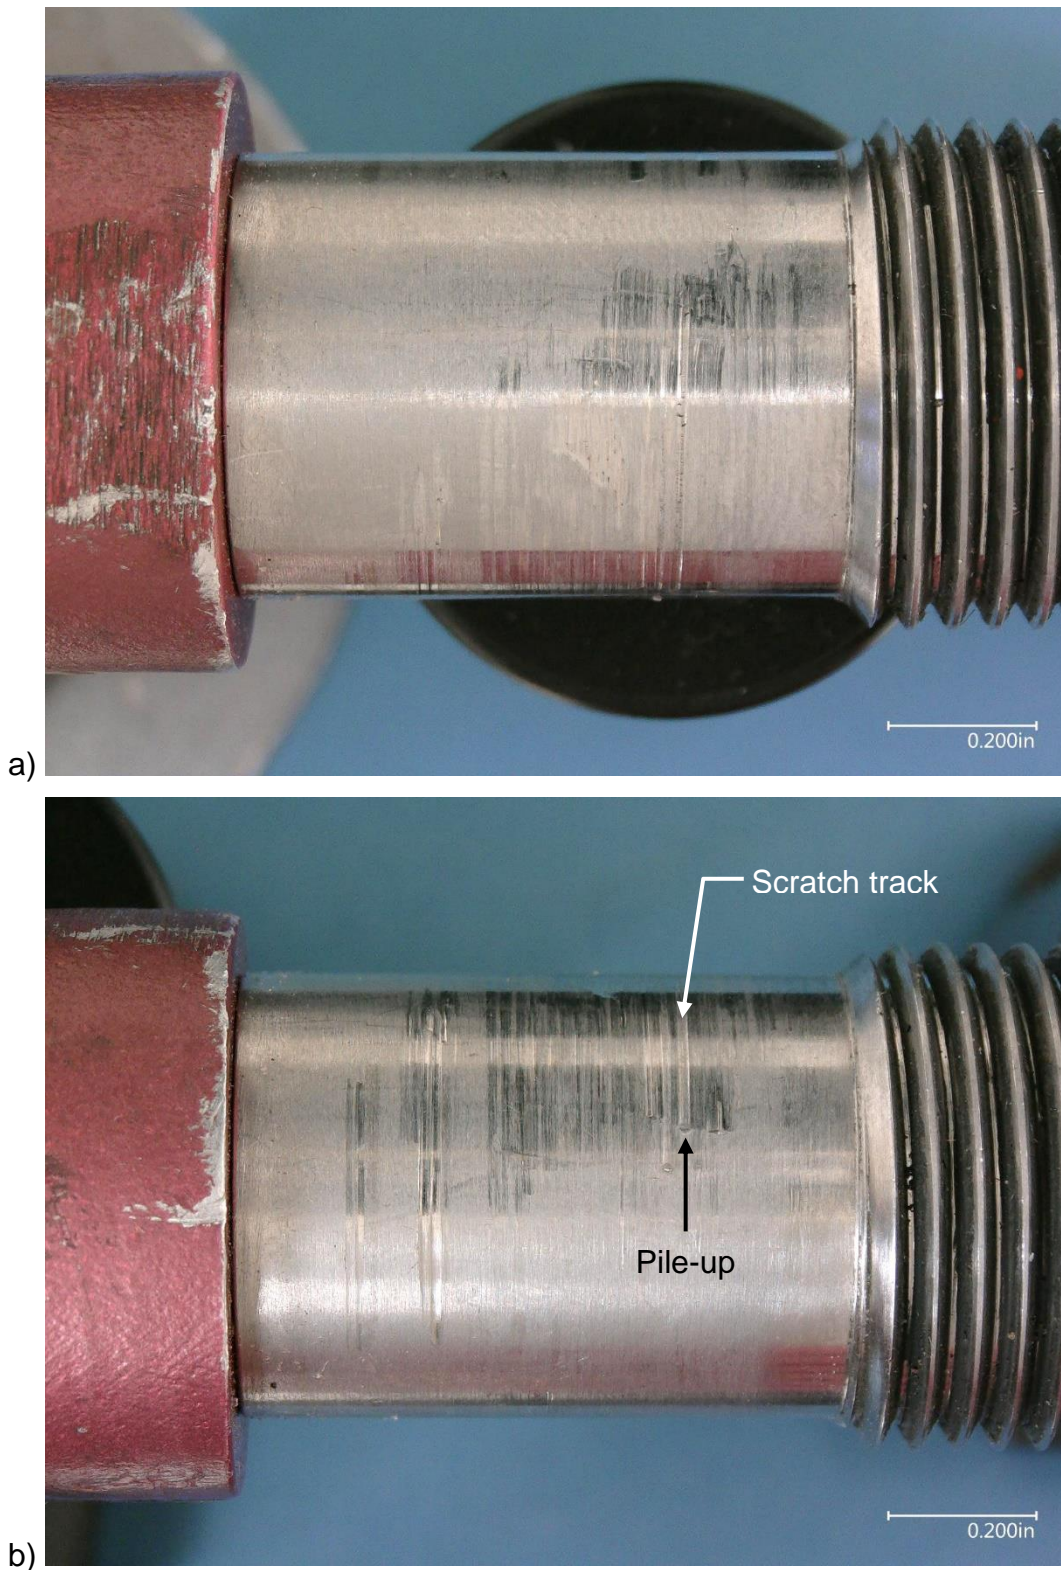
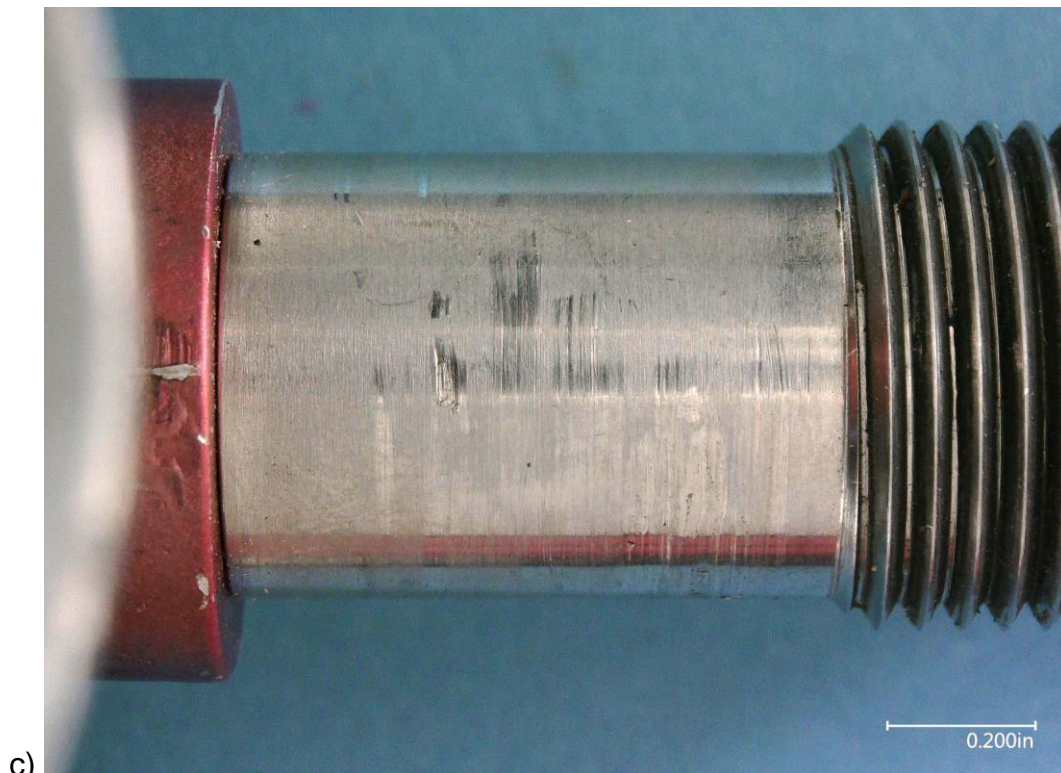
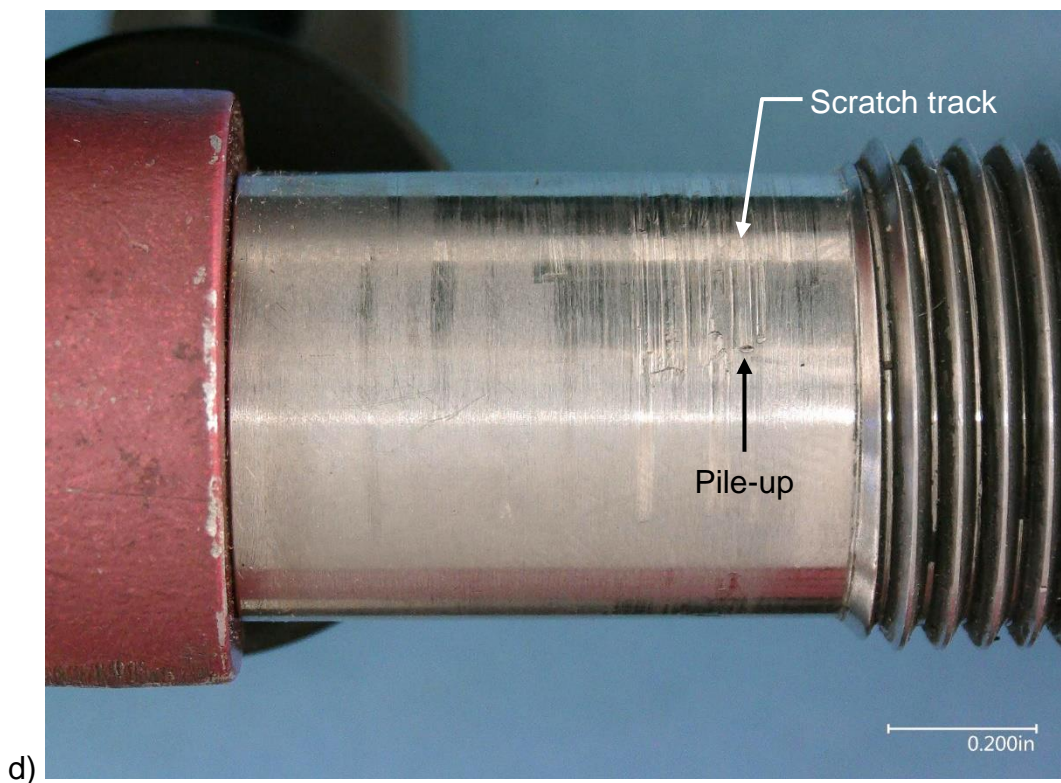
Also before disassembling the valve, the visible smooth-barrel portion of the pipe was examined, as shown in figures 4a – 4d (see figure 2 for clock position identification). Circumferential scratch marks were observed around the barrel of the pipe. Viewed from the outlet end of the pipe, several scratches appeared to progress in the counterclockwise direction ending at a pile-up of material, such as the features indicated in figures 4b and 4d.

**Figure 4:** Optical microscope images showing circumferential scratch marks and pile-up material on the outer diameter surface of the pipe barrel: a) 12:00; b) 3:00;

**Figure 4 (cont.):** c) 6:00; and d) 9:00.

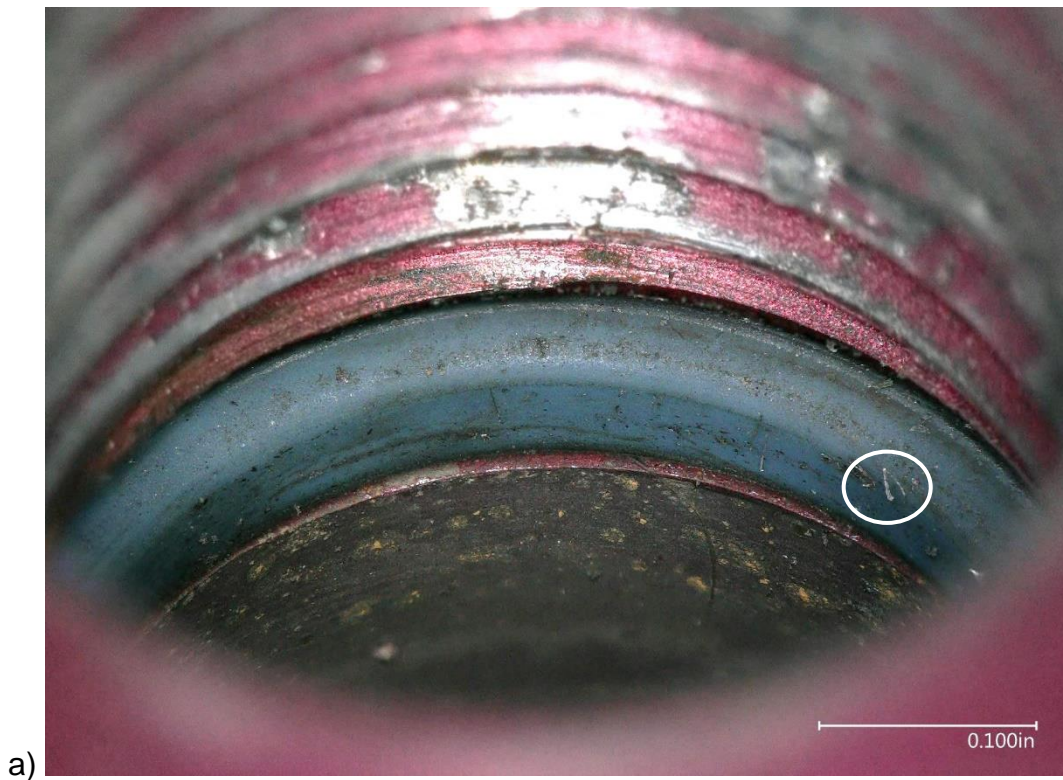
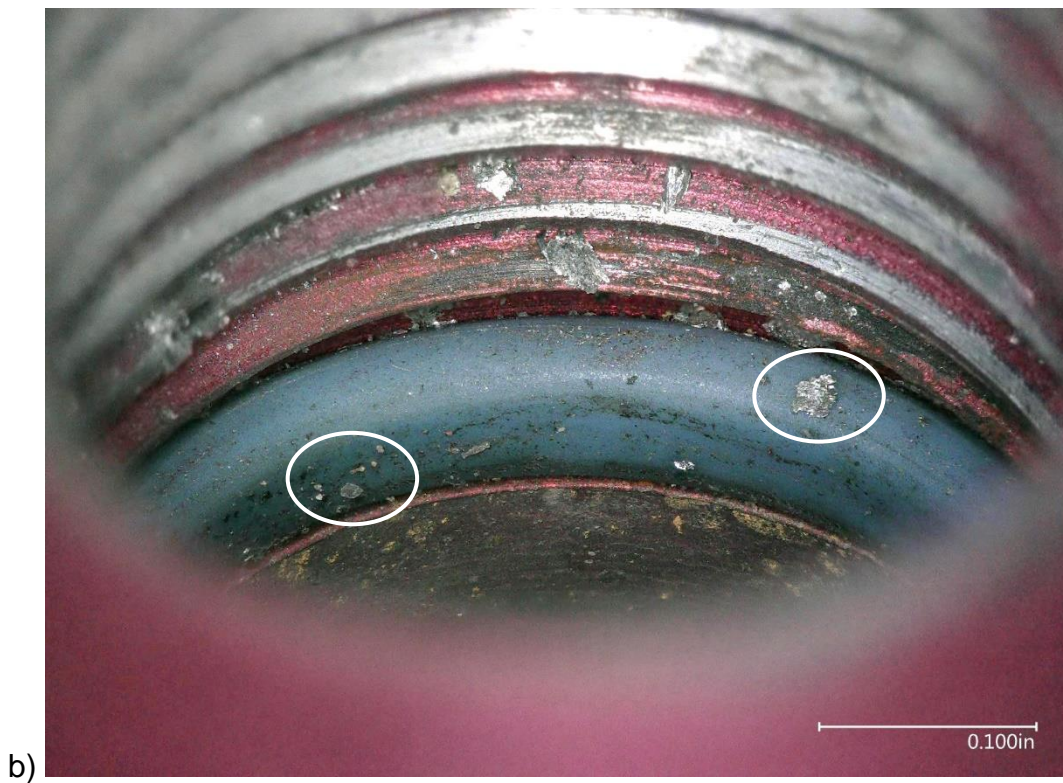
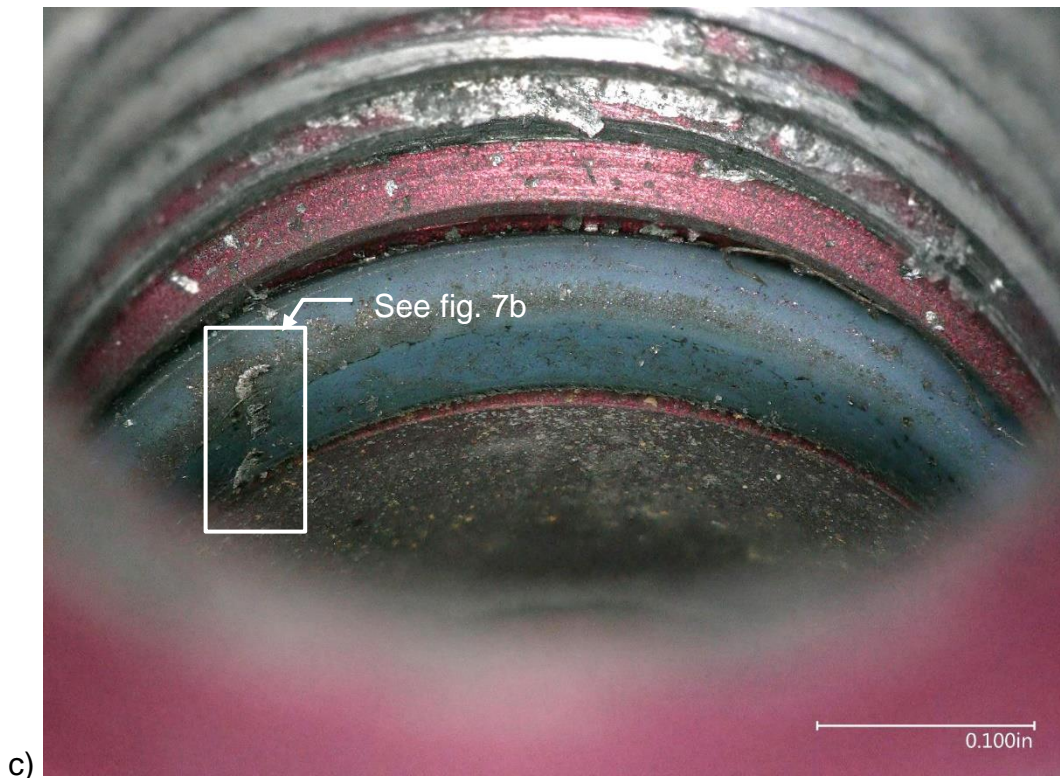
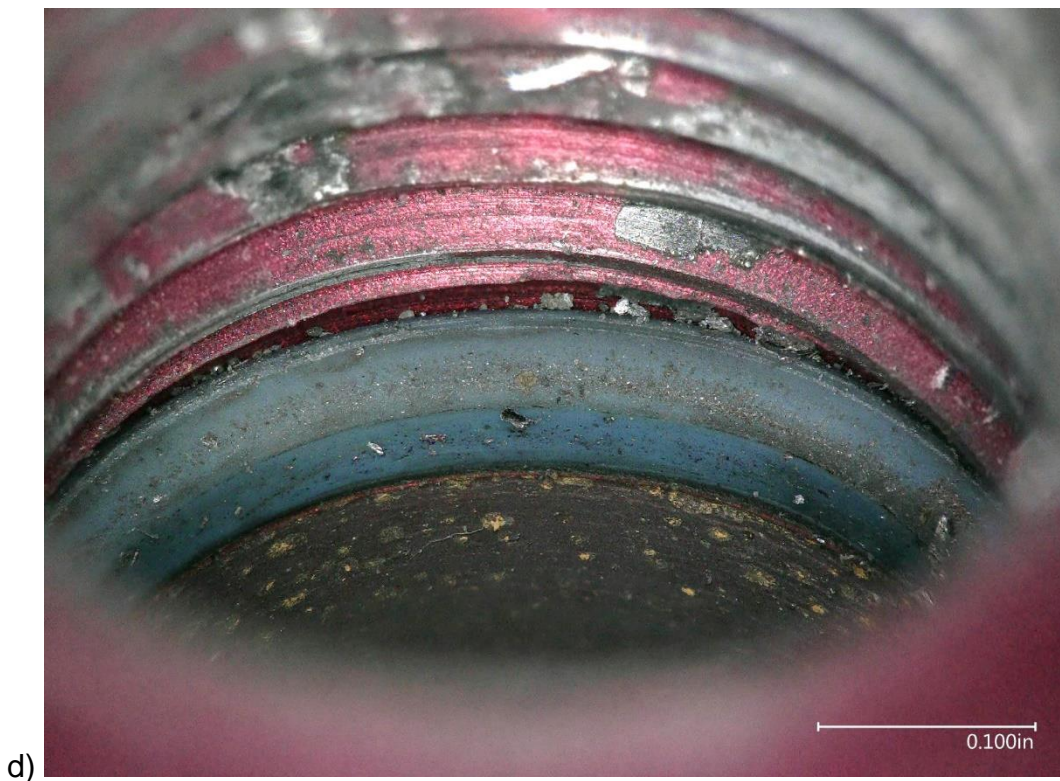
The pipe was then unthreaded from the elbow fitting. A disposable towel was wrapped around the threaded portion of the pipe and then a pair of pliers was used to grip the pipe/towel assembly. The pipe unthreaded instantly, requiring a minimal amount of applied torque. After the pipe was removed, the O-ring and inner diameter of the fitting were examined using a stereomicroscope. Images of the O-ring, as-seated in the fitting at 90° intervals, are shown in figures 5a – 5d and the threads at the opening to the fitting at the 9:00 and 3:00 positions are shown in figures 6a and 6b, respectively. Metal chips were observed on the O-ring surface as indicated in figures 5a – 5d. Examination of the fitting threads revealed that the first two threads at the 9:00 and 3:00 positions were damaged due to cross-threading, as indicated in figures 6a and 6b.

**Figure 5:** a) 12:00; b) 3:00

**Figure 5 (cont.):** c) 6:00; and d) 9:00

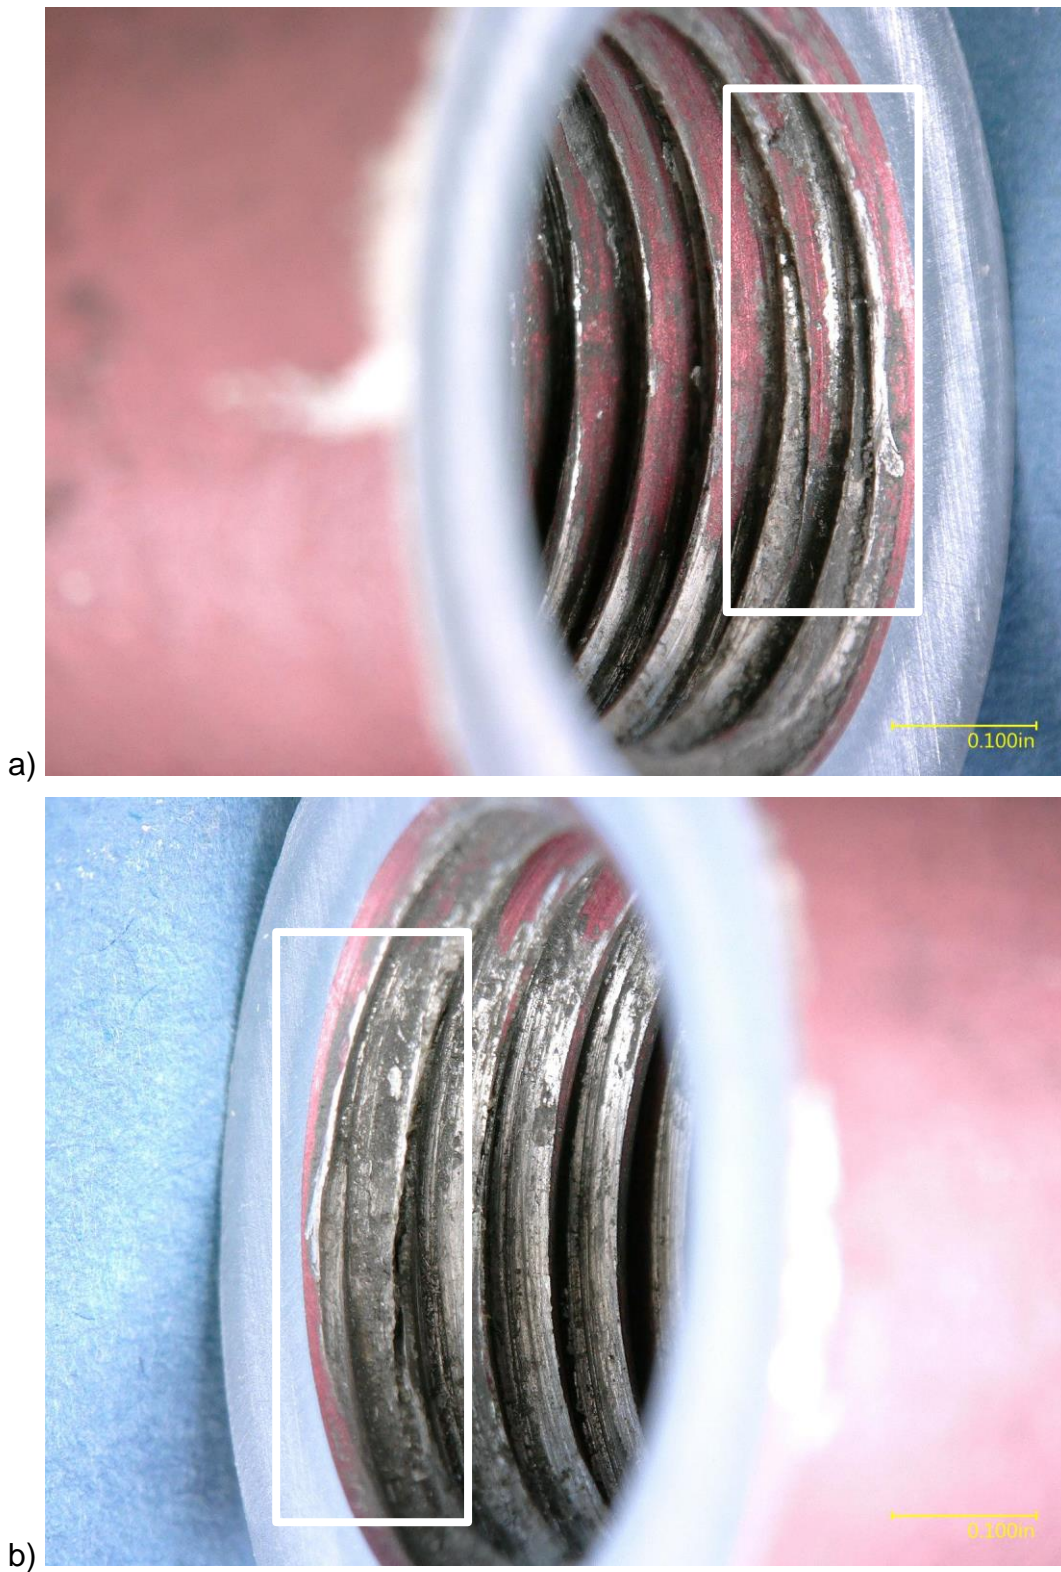
**Figure 6:** Optical microscope images showing cross-threading of the female threads on the elbow fitting: a) 9:00 and b) 3:00.

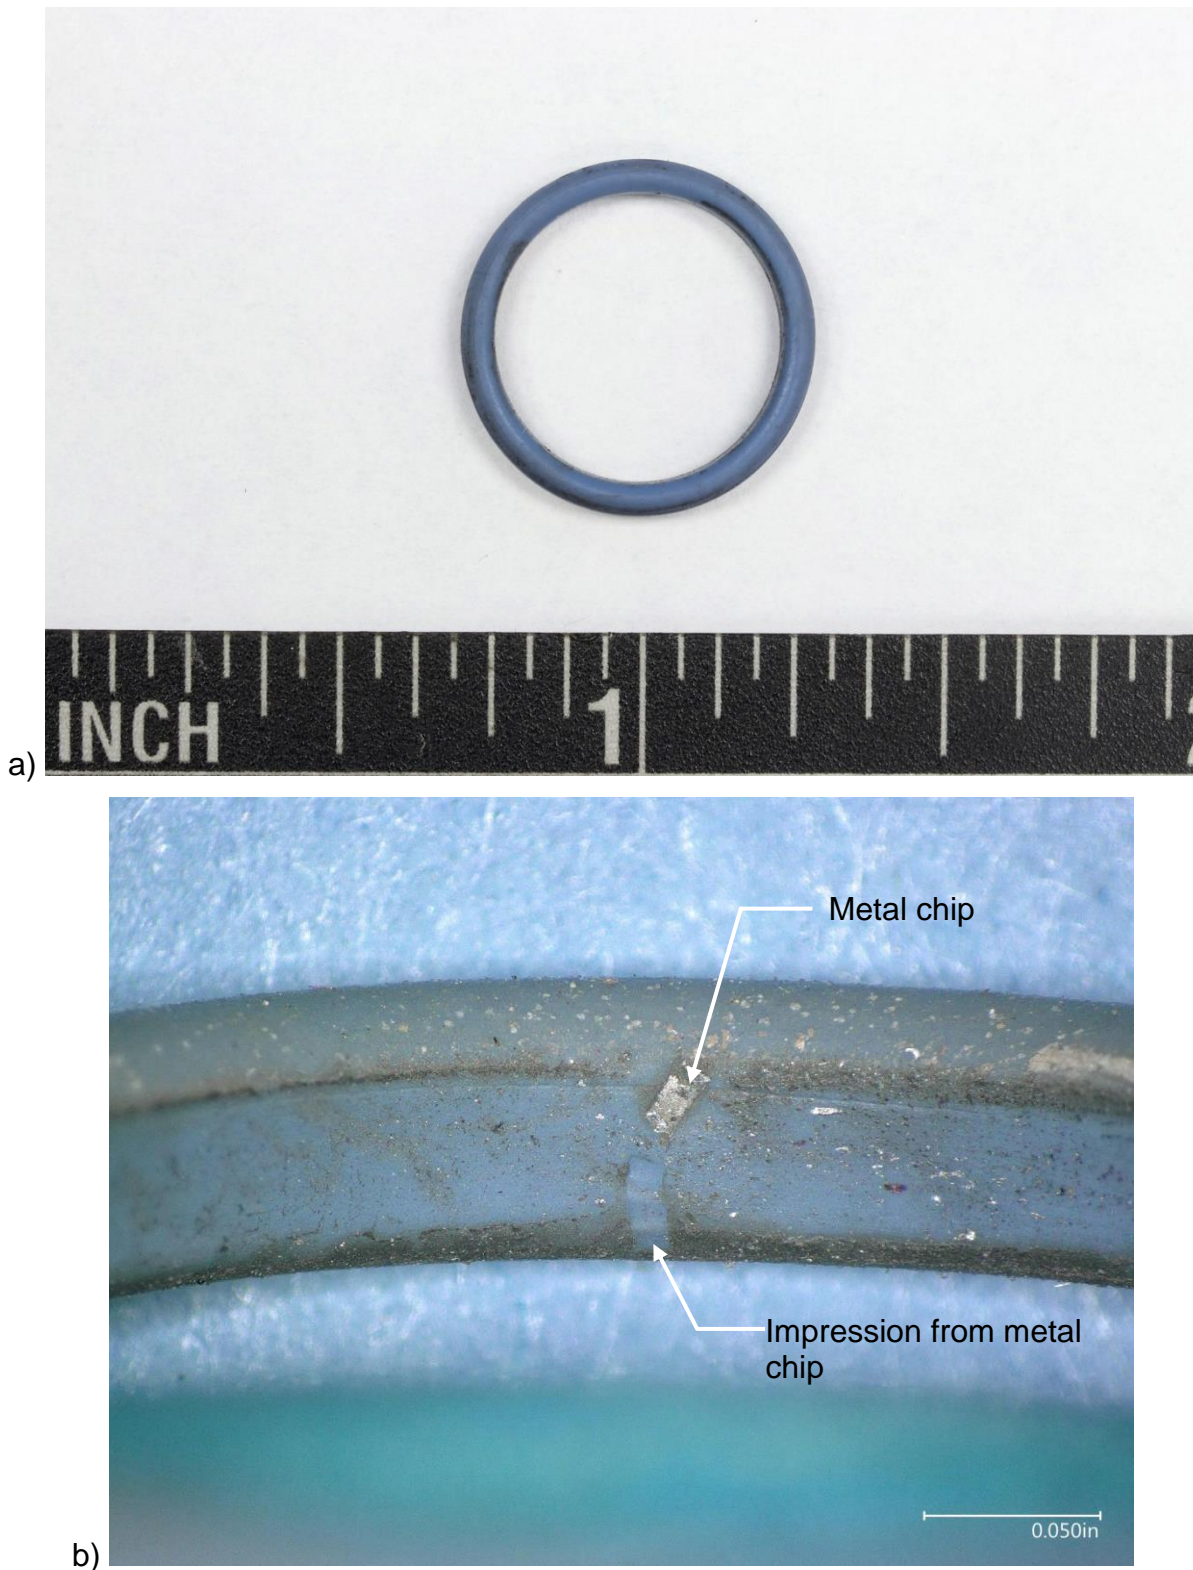
The O-ring was removed with a pick and is shown in figure 7a. The O-ring had a flat outer diameter and inner diameter surface, the latter shown in figure 7b. The region of the O-ring indicated in figure 5c, highlighting two metal chips near the 6:00 position, is shown in figure 7b. During removal of the O-ring, one of the chips fell off, revealing an impression left in the rubber, as indicated in the figure.

**Figure 7:** a) Overview image of the O-ring and b) higher magnification image of the O-ring showing metal chips that were embedded in its inner diameter surface.

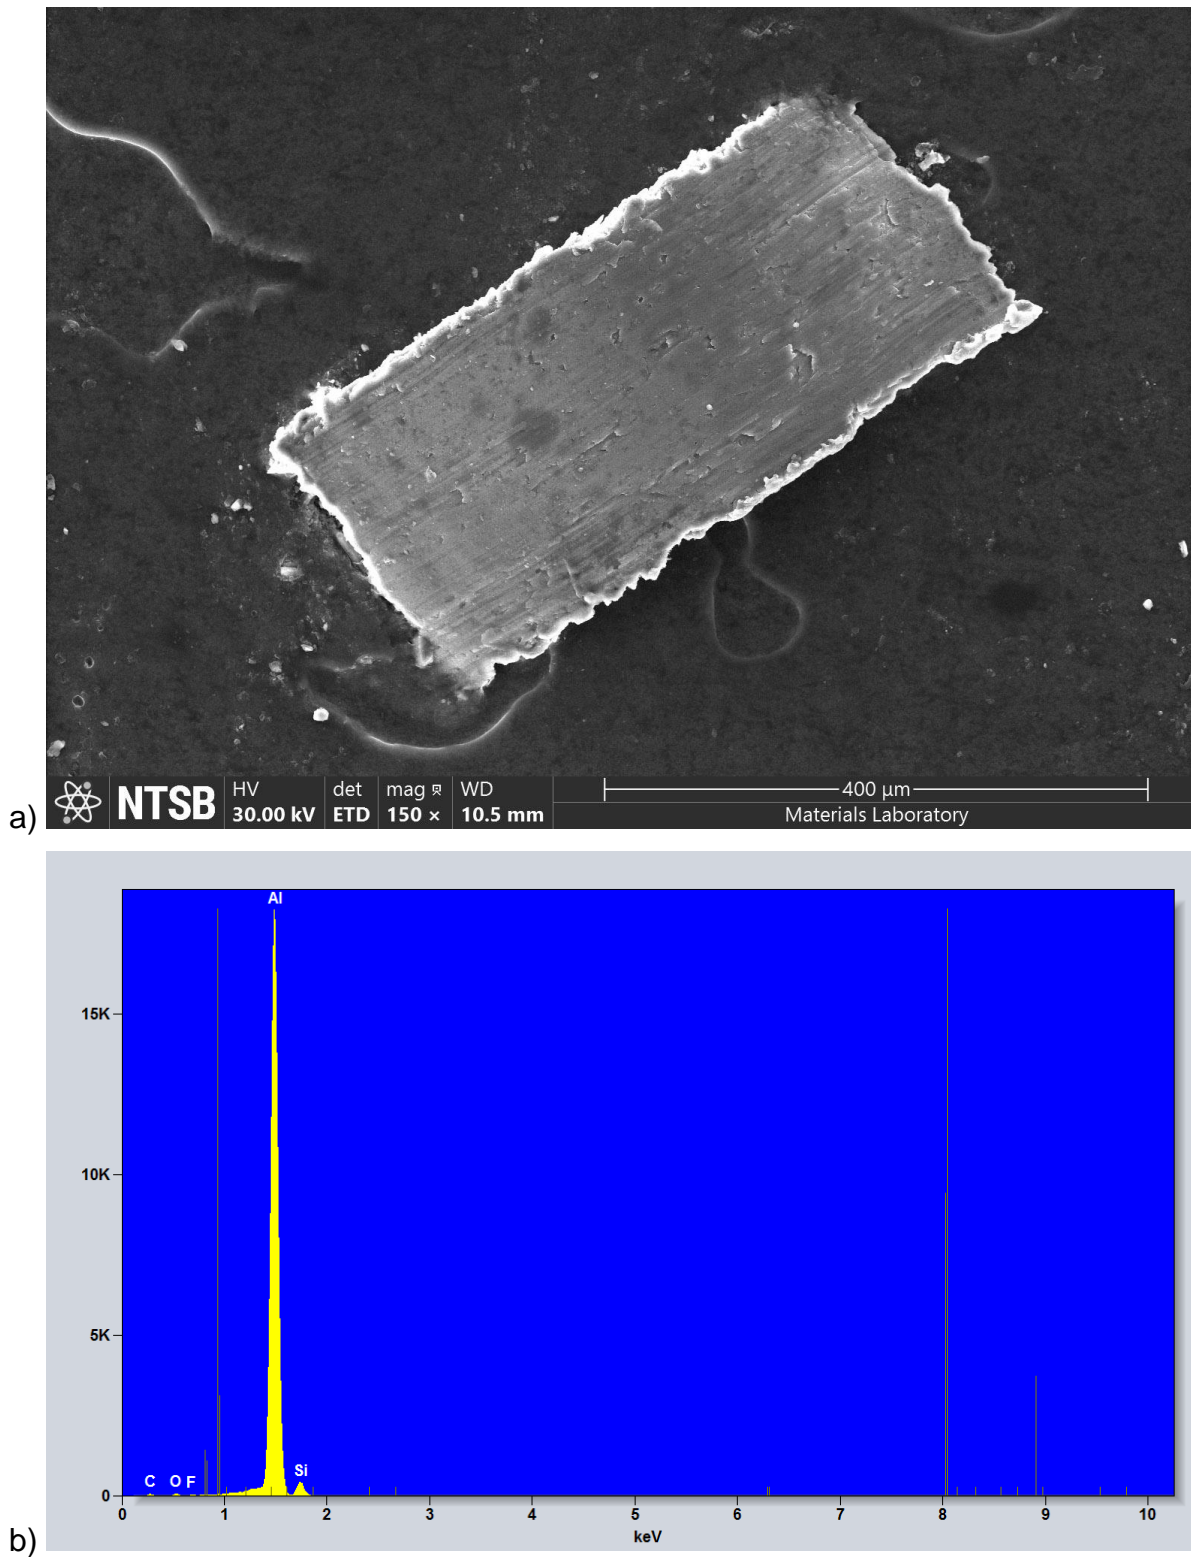
The remaining chip was lifted off the O-ring using a piece of carbon tape and was examined using a scanning electron microscope (SEM) equipped with an energy dispersive X-ray spectrometer (EDS) (an impression was also left in the rubber O-ring by this chip). An SEM image of the chip is shown in figure 8a and an EDS spectrum from the chip is shown in figure 8b. The chip was composed primarily of aluminum (Al) and silicon (Si). Comparison EDS spectra of the elbow fitting and the pipe were gathered and are shown in figures 9a and 9b, respectively. The spectrum from the elbow fitting consisted of Al and Si, similar to the chip, while the pipe spectrum consisted primarily of iron (Fe), chromium (Cr), nickel (Ni), and copper (Cu), consistent with a stainless steel.

**Figure 8:** a) SEM image of the metal chip removed from the O-ring and b) EDS spectrum from the chip showing the presence of aluminum and silicon, consistent with an aluminum alloy.
